Client Name: Example Hospital

Site Name: Example Hospital

Assessment Date: 20/07/2010

Executive Summary

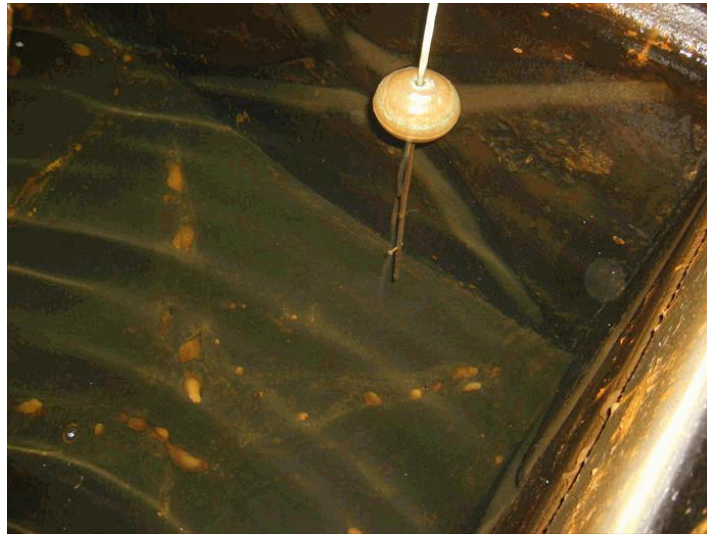
The main cisterns are old steel vessels that have been painted internally but are generally in poor order and need replacing.

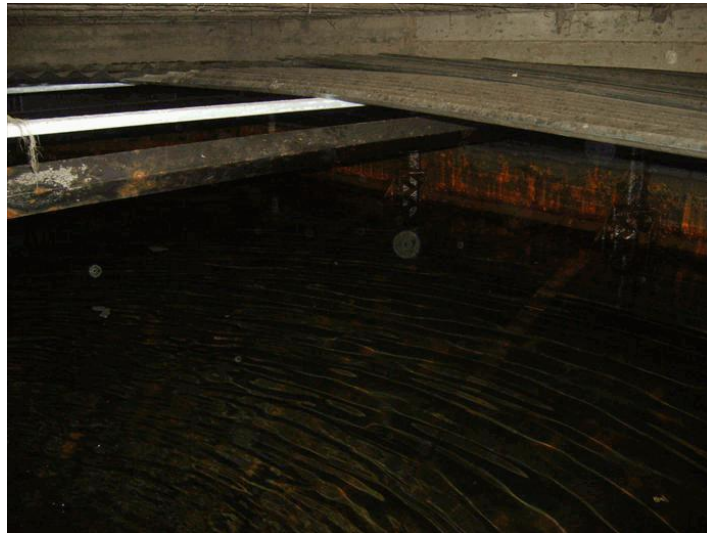
As can be seen the cisterns are not well enclosed or up to water bye law requirements.

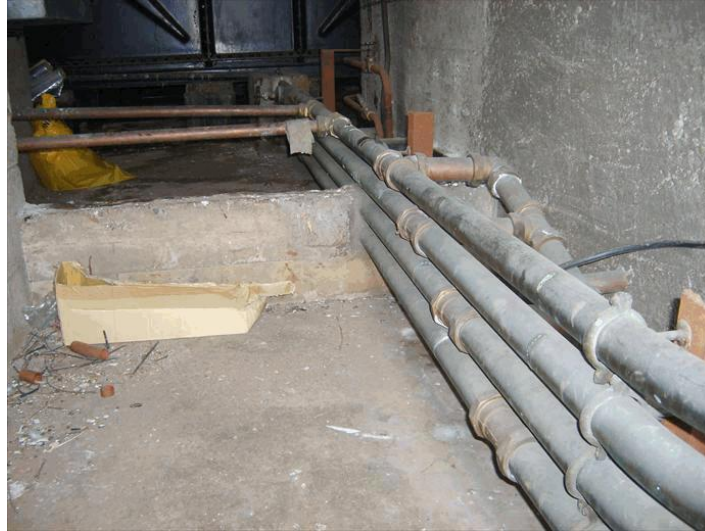
Primary cold water pipes are not insulated and the general area is in poor order.

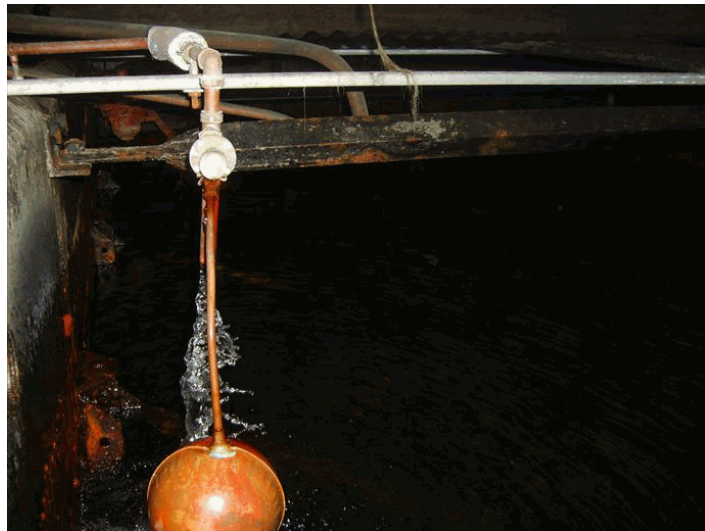
This second supply was working hard when we surveyed the site. It is not dosed with chlorine dioxide.

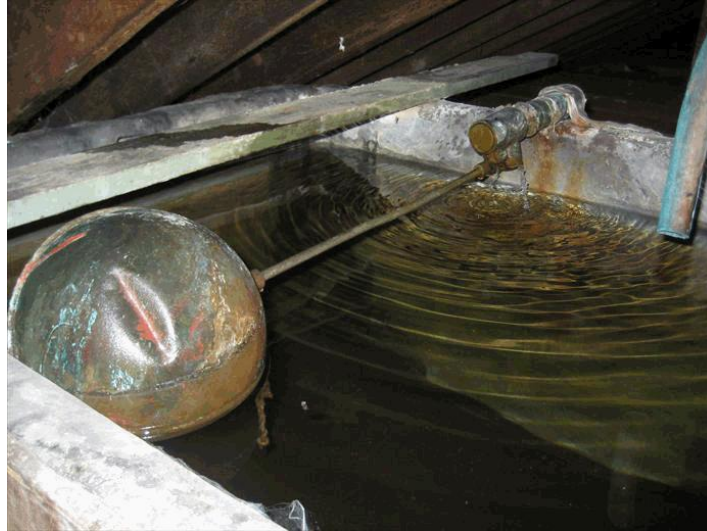
The old building has a few outlets served by an old wooden (lead lined) cistern that needs to be removed.

Disconnect and remove the cistern together with any redundant pipe work and water services. The services fed can be supplied by the main cisterns.

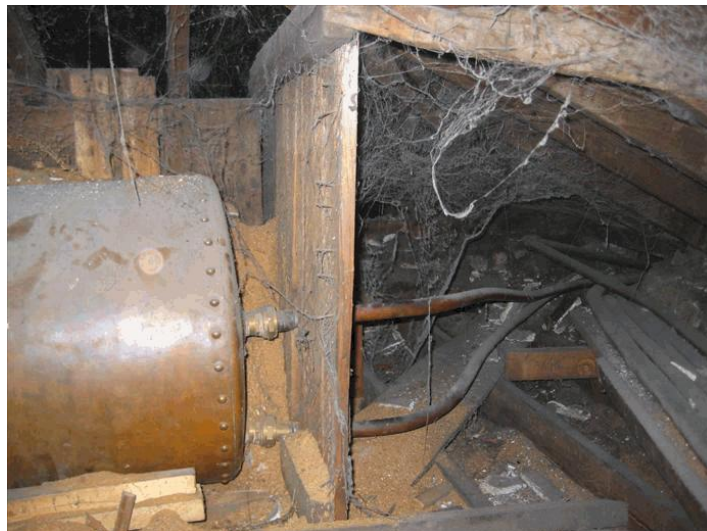
If the unit fed patient areas we would have issued a risk rating of 4. The heater should not remain working at this temperature. Remove the water heater and connect any served outlets to the main HWS running close to the same locations.

The old building has a few outlets served by an old uninsulated water heater running at very poor temperatures. We could not follow pipes for supply or feed but suspect this unit could be removed from service.

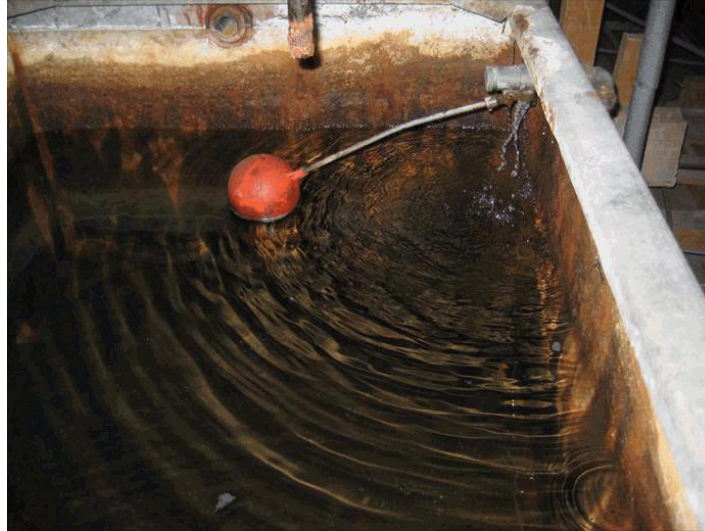
An old galvanised cistern in need of replacement.

The cistern needs to be replaced with a new water reg compliant cistern incorporating all other recommendations made here.

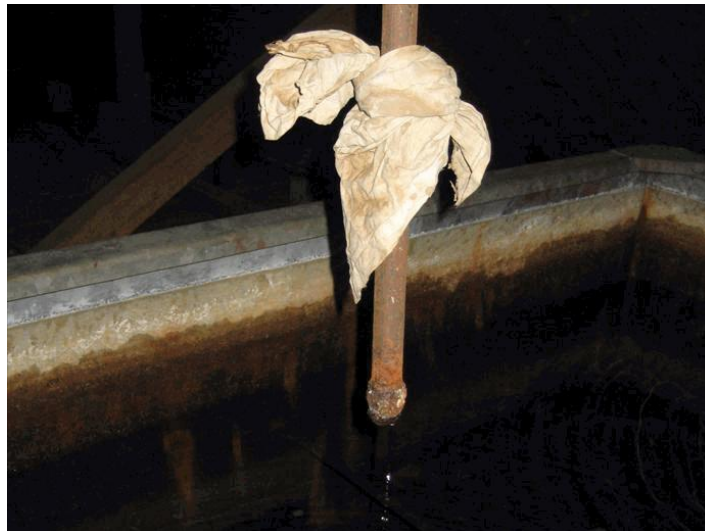
Primary heating should not vent back to CWDS and need redirecting.

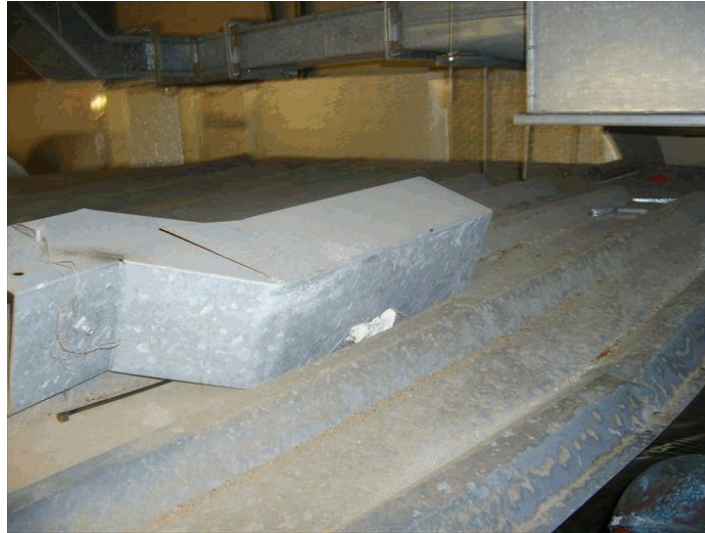
Unit 4, 5 and 6 cistern lid is not compliant and needs replacing.

A new lid and inspection hatch is needed with minor other works.

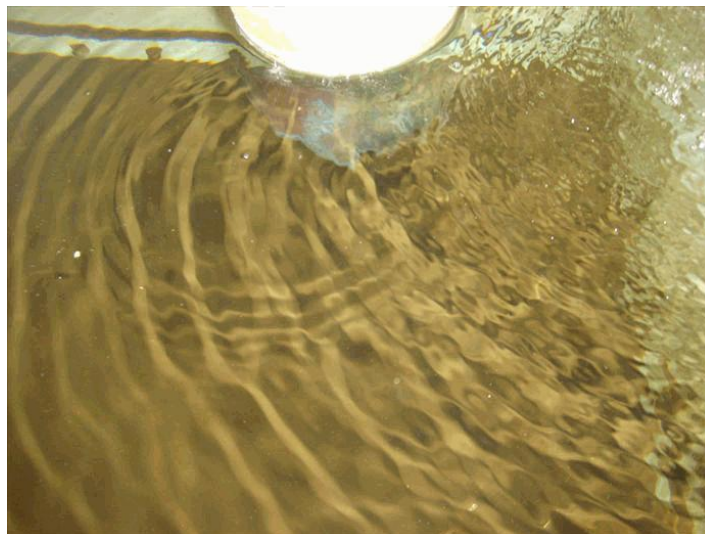
Unit 4, 5 and 6 cistern is a little grubby and needs to be cleaned and disinfected.

The cistern needs to be cleaned and disinfected in accordance with ACOP L8.

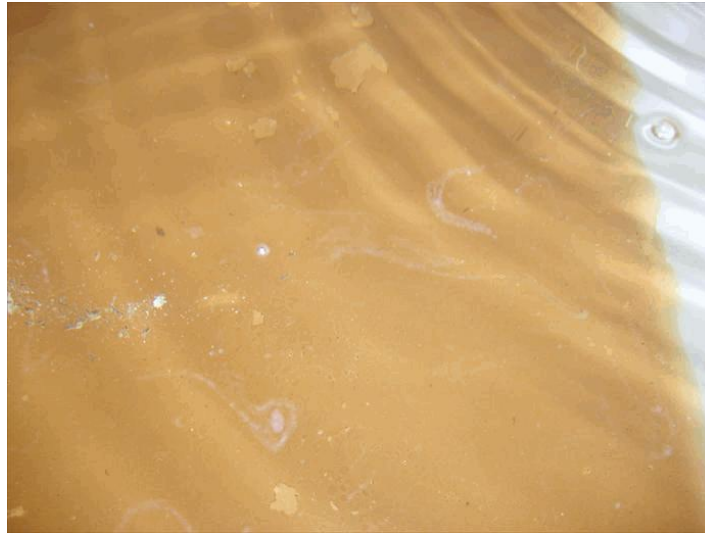
Unit 7 and 8 cistern is a little grubby and needs to be cleaned and disinfected.

The cistern needs to be cleaned and disinfected in accordance with ACOP L8.

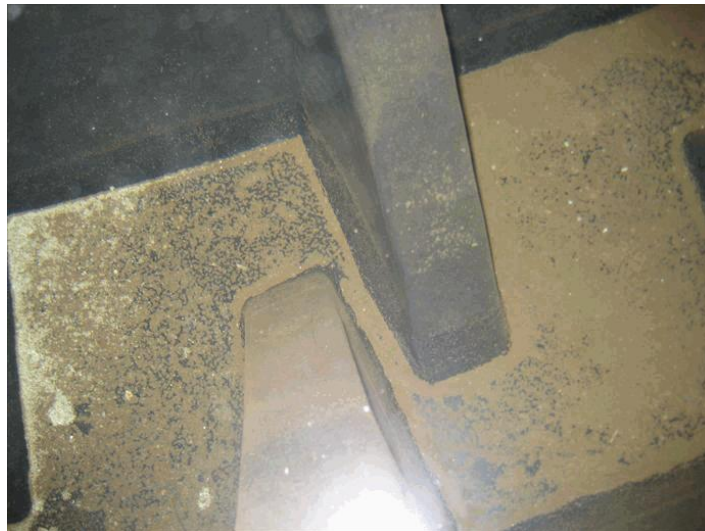
Facilities management cistern is a little grubby and needs to be cleaned and disinfected.

The cistern needs to be cleaned and disinfected in accordance with ACOP L8.

A rigid close fitting lid should be fitted along with a few other minor improvements.

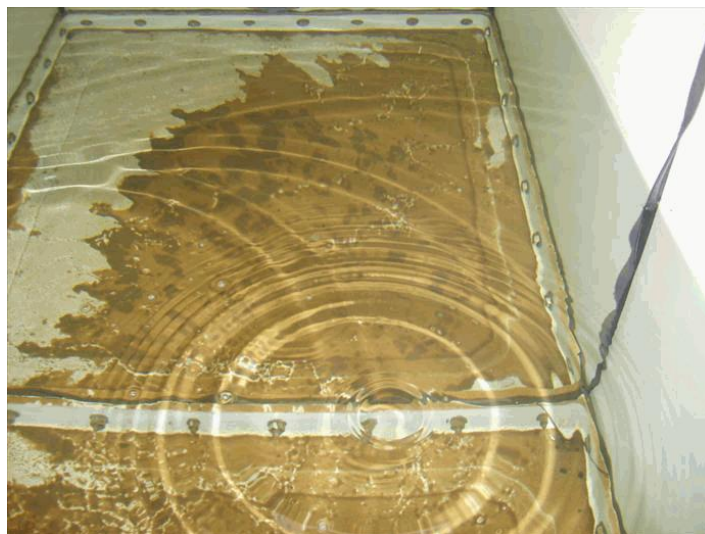
Due to the external location the cistern is externally rather dirty. A clean would reduce the risk of debris entering the cistern during inspections.

Laboratory cistern is a little grubby and needs to be cleaned and disinfected.

The cistern needs to be cleaned and disinfected in accordance with ACOP L8.

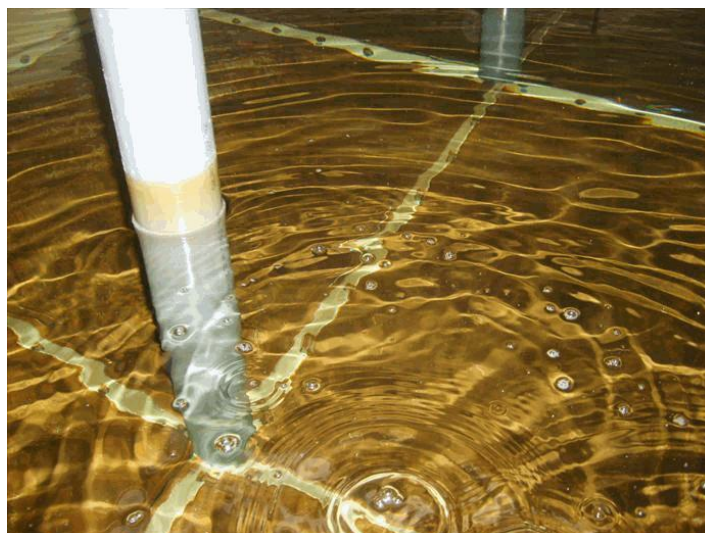
Lodge cistern is a little grubby and needs to be cleaned and disinfected.

The cistern needs to be cleaned and disinfected in accordance with ACOP L8.

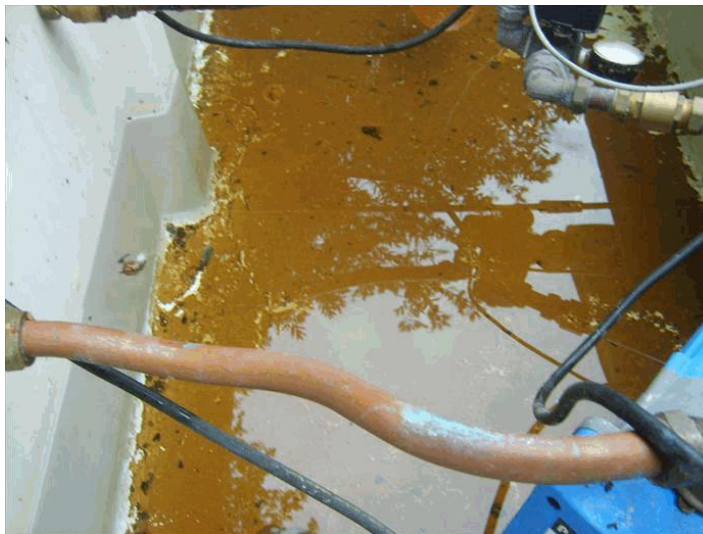
OPD instrument cistern is a little grubby and needs to be cleaned and disinfected.

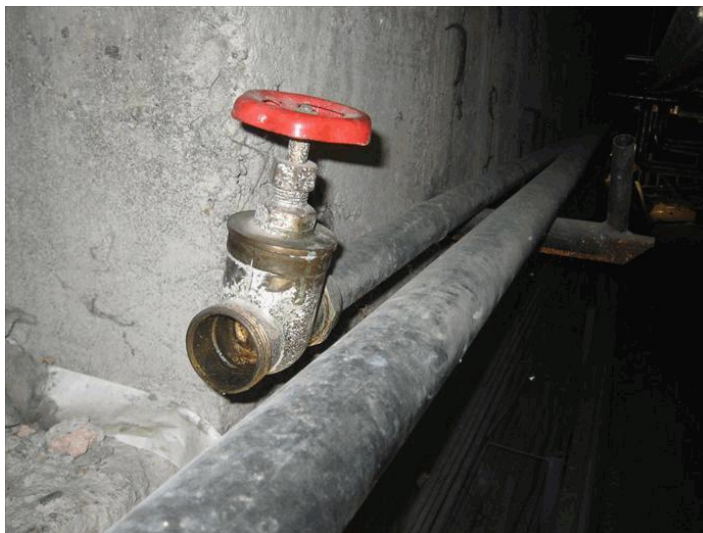
During our survey we could not trace all pipework from source to destination. We think this pipe heading to the water heaters may have been the old cold feed and that it is still linked to the main cisterns.

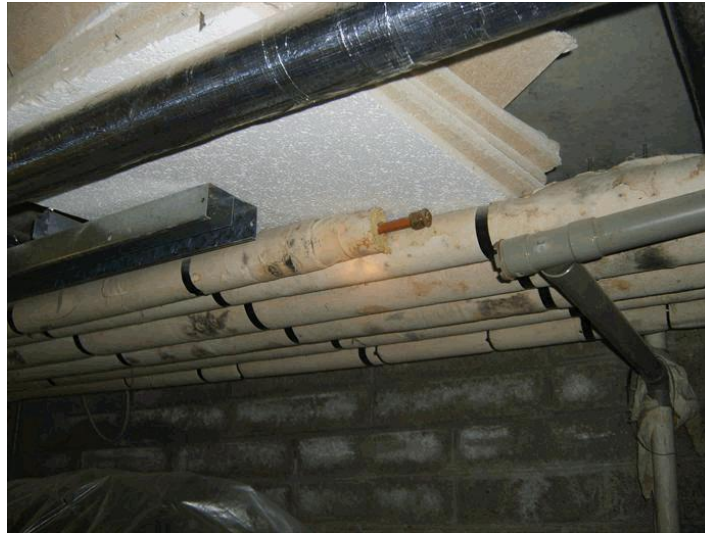
HWS Outlets and system –
Dead legs should be removed as identified on our schematic drawings. The flow and return circuit is not operating and has created large dead legs under units 1 and 2. The end of the line has been capped, this requires attention.

During our survey we could not trace all pipework from source to destination. The hot water service flow and return is not working under units 1 and 2. At the end of the HWS a closed valve was found.

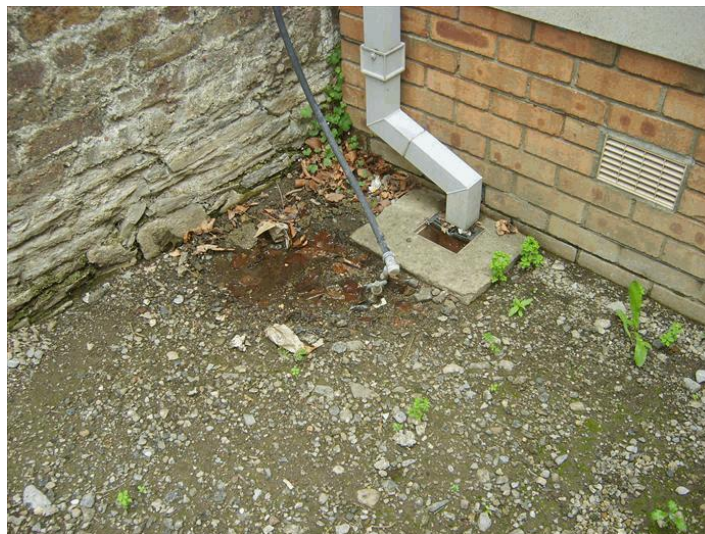
A mains water feed lying on the ground near the education building is both a dead leg and a back flow risk for the drinking water.

Surveyor's Answer: Lines like those found by Education are a concern.
